COMMONWEALTH OF KENTUCKY
BEFORE THE PUBLIC SERVICE COMMISSION

LOUISVILLE GAS AND ELECTRIC COMPANY)
)
 _____) CASE NO. 97-174
)
 ALLEGED VIOLATIONS OF ADMINISTRATIVE)
 REGULATION 807 KAR 5:041)

**UTILITY ACCIDENT
INVESTIGATION REPORT**

INVESTIGATION REPORT

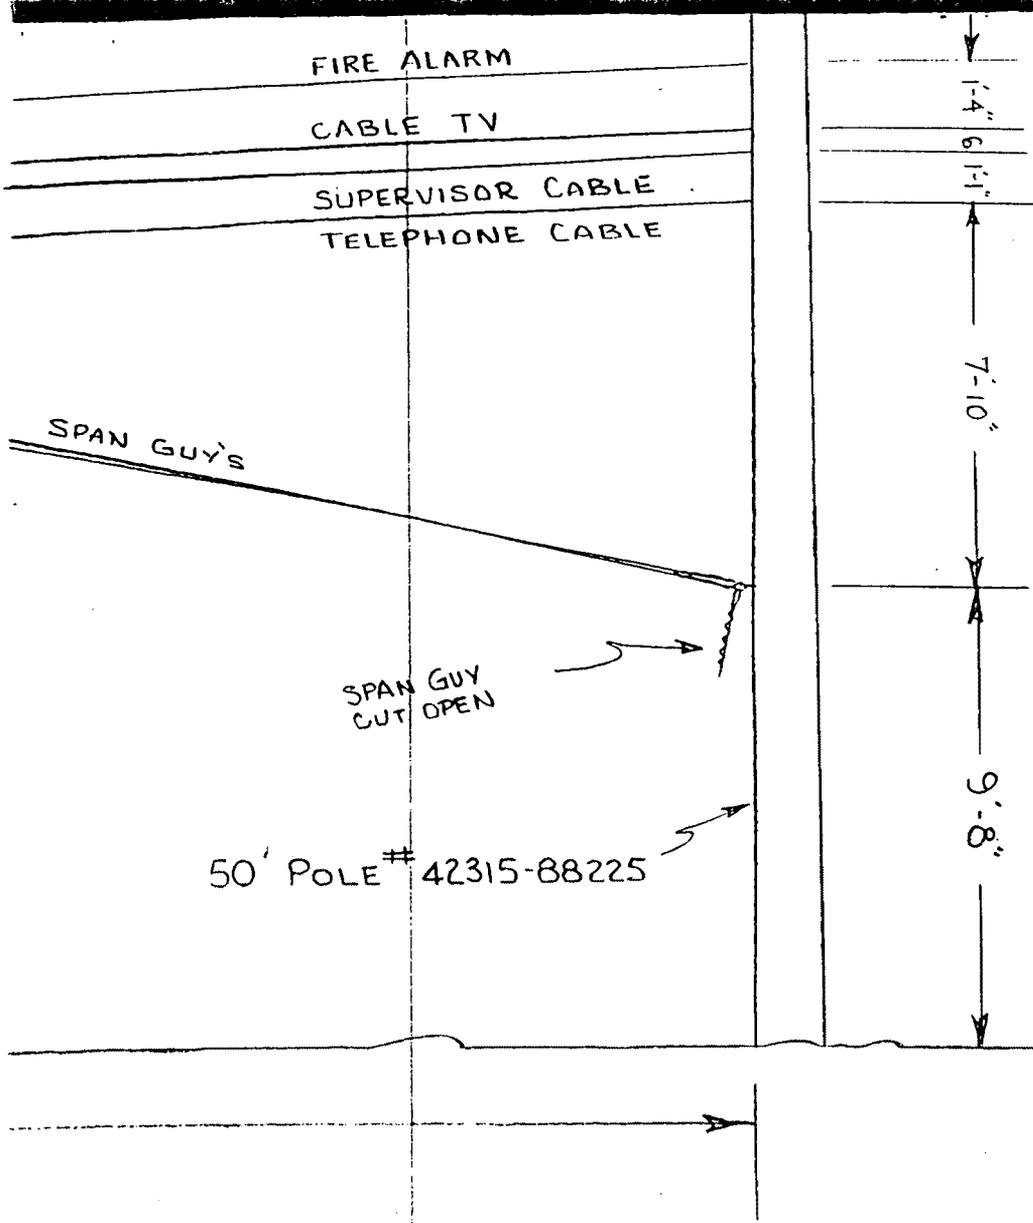
SKETCH SHOWING POLE # 42315-88225
 AND POLE # E2-2468 IN FRONT OF
 1020 W. MARKET ST. WHERE ACCIDENT
 OCCURED TO CHARLES SHEARD 10-16-96
 NO SCALE DRAWN BY R.W. HASCH

There are two trees involved in this incident. The larger tree, directly in front of 1020 West Market Street, is the one Mr. Sheard advises he touched, and a smaller tree, which is located just west. The larger tree has limbs which have grown into the incandescent wire. The smaller tree suffered fire damage on the evening of October 16. All that remains of the smaller tree is a burned stump. The fire department removed the rest of the tree on October 16. The concrete on the sidewalk surrounding the stump of the small tree contains several burn marks. According to Mr. Hasch, these are indicative of incandescent circuit voltage.

The incandescent lighting circuit would not have been energized on October 16 until dark when the photocell closed the circuit. It appears the guy wire picked up current directly from the incandescent and transferred the current to the tree.

Mr. Campbell requested the Forestry Department send a crew to trim the tree limbs close to the incandescent circuit. This work was completed on October 18.
