Shelby Energy  
Cooperative

# Electric Distribution Utility Annual Reliability Report

UTILITY NAME	Shelby Energy Cooperative, Inc.
REPORT PREPARED BY	Distribution System Solutions, Inc. and Shelby Energy Cooperative
E-MAIL ADDRESS OF PREPARER	davidg@shelbyenergy.com
PHONE NUMBER OF PREPARER	502 633-4420

CALENDAR YEAR OF REPORT	2013
-------------------------	------

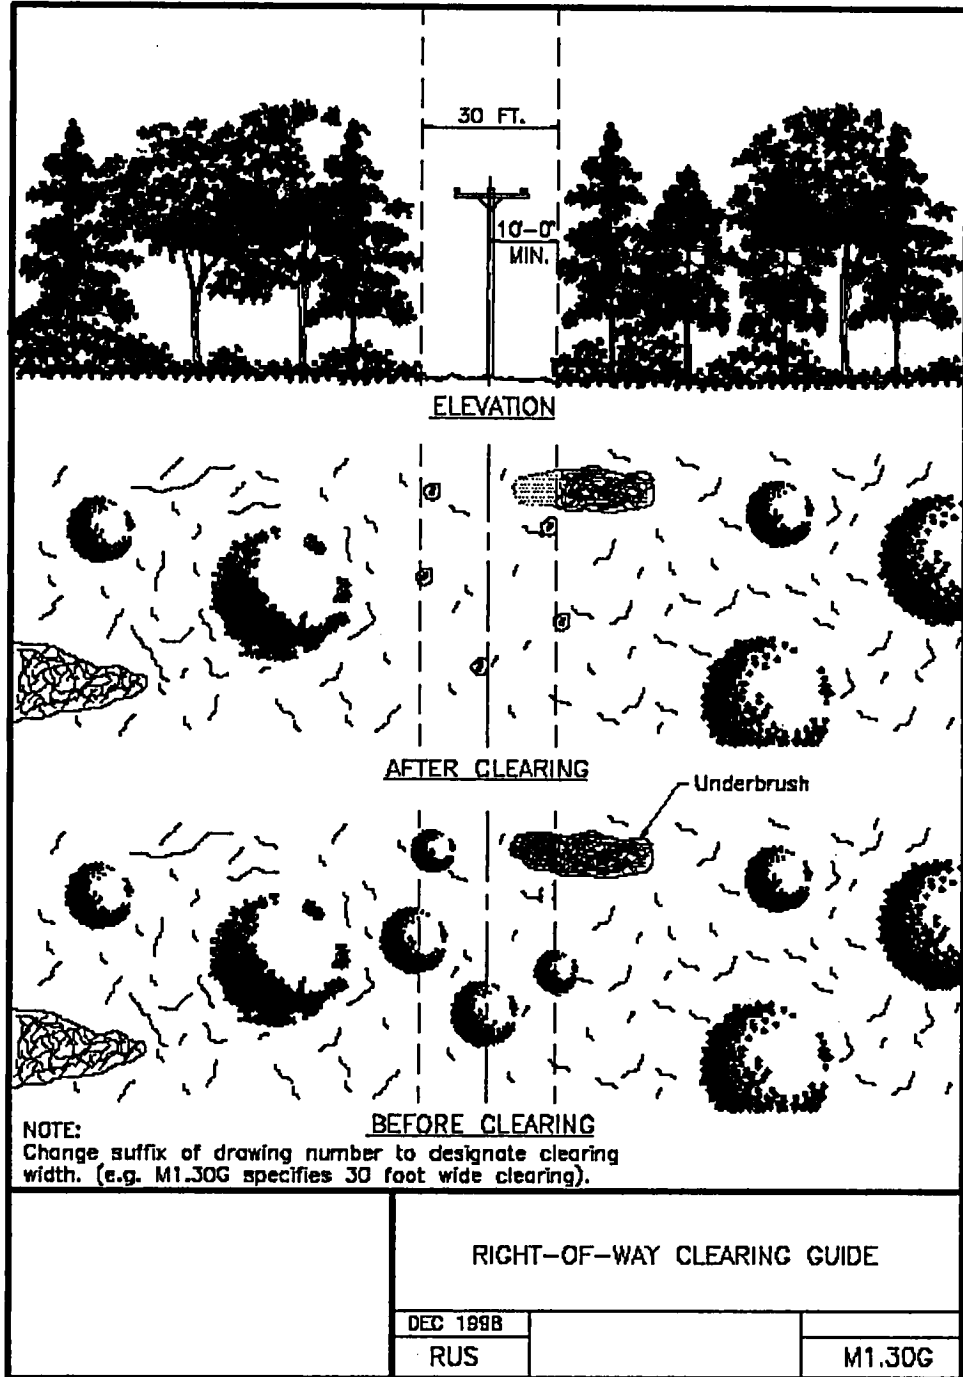
**Exhibit #2**

**SECTION 6: VEGETATION MANAGEMENT REVIEW AND PLAN**

Shelby uses a clearing cycle of five (5) to six (6) years that combines ROW trimming, spraying and mowing. The variance of five (5) to six (6) years is used to adjust the clearing cycle based on yearly growing conditions. This in turn helped Shelby prioritize the circuits to be managed. Hourly contract cutting crews are utilized by Shelby with no less than one (1) crew working year around as weather and/or work permits.
